AUTOLIV (CHINA) AUTOMOTIVE SAFETY SYSTEMS CO., LTD
Sizing and Beaming
MODEL N/A SERIAL N/A ASSET:NA

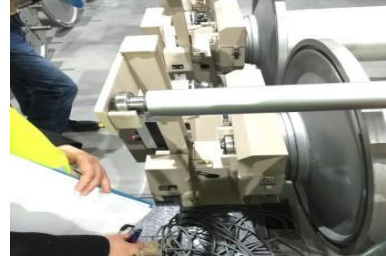
注释1)

对应客户风险点编号: 14

客户提出的风险点: 齿轮放入不到位, 运转时易掉落

Risk point NO: 14

Risk claimed by client: the gear can't reach the right position and it's easy to fall down when it running.

整改措施: 在齿轮下放处加装限位开关, 如果齿轮未到位, 限位开关未收到到位信号, 设备不能运转。安全限位开关符合标准: GB14048.5。

Remediation solution: install the rolling limit switch under the position where the gear should reach, the equipment can't run without the signal send by the rolling limit switch when the gear not reach the right

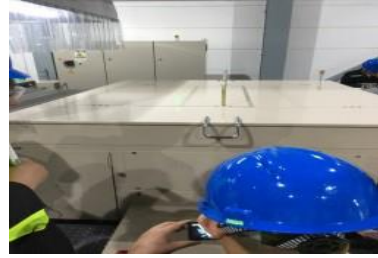
注释1)

对应客户风险点编号: 11

客户提出的风险点: 上浆机烘箱盖板抬起后易发生掉落

Risk claimed by client: the cover board of the oven easy falling

整改措施: 在上浆机上方增加横杆, 用链条锁进行悬挂。当烘箱盖板抬起后, 用链条锁将盖板悬挂在 Risk point NO: 11

Remediation solution: add rail hung by the chain lock. When open the cover board of the oven, we can lock the board to the rail. So to prevent the incident of fall down of the 注释2)

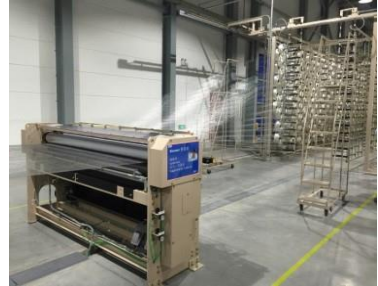
对应客户风险点编号: 12, 13

客户提出的风险点: 正常生产时机器两侧进入禁止

Risk claimed by client: forbid to go into the machine from both sides when operating the equipment.

解决措施: 增加防护栏(长度2.7m, 宽度2m)加装安全门锁, 当设备运转时安全门锁锁定, 人员无法接触到运行的设备。设备前方安装安全光幕(光幕检测幅度1.6m, 检测长度最大可达到20m)防止人员在设备运行时进入危险区域。安全光栅符合标 Risk point NO: 12, 13

Remediation solution: install the safeguarding barrier (2.7m length) and interlock. People can't touch operating equipment when the locking. Install the light curtain in front of the equipment (the screen can detect the limit of 1.6 m range and 20m length) to prevent people in the dangerous area when the equipment is running. The light curtain meet the need of

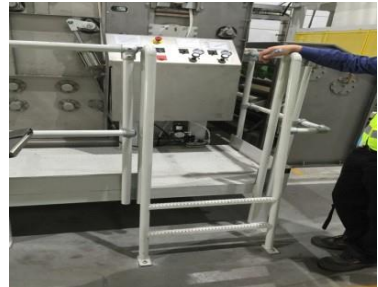
注释3)

对应客户风险点编号: 41

客户提出的风险点: 踏步太窄

Risk point NO: 41

Risk claimed by client: the footplates are too narrow

解决措施: 将目前的踏步更改为阶梯踏步形式。

Remediation solution: change the present narrow footplates to the wide ones.
